Intel® E8870 (870) Chipset

Specification Update

May 2004

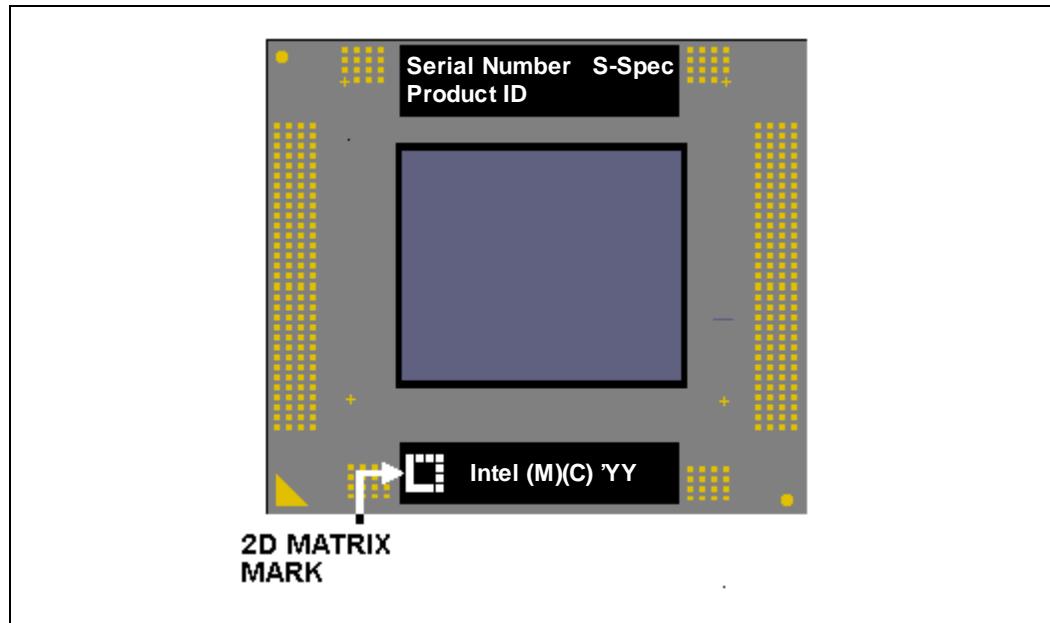
Figure 1-1. SNC/SIOH/SPS Markings

Figure 1-1 shows an example of the SNC and SIOH component markings which include the following information:

- INTEL Brand/ INTEL Product ID
- Legal Mark
- Serial Number
- S-Spec Number

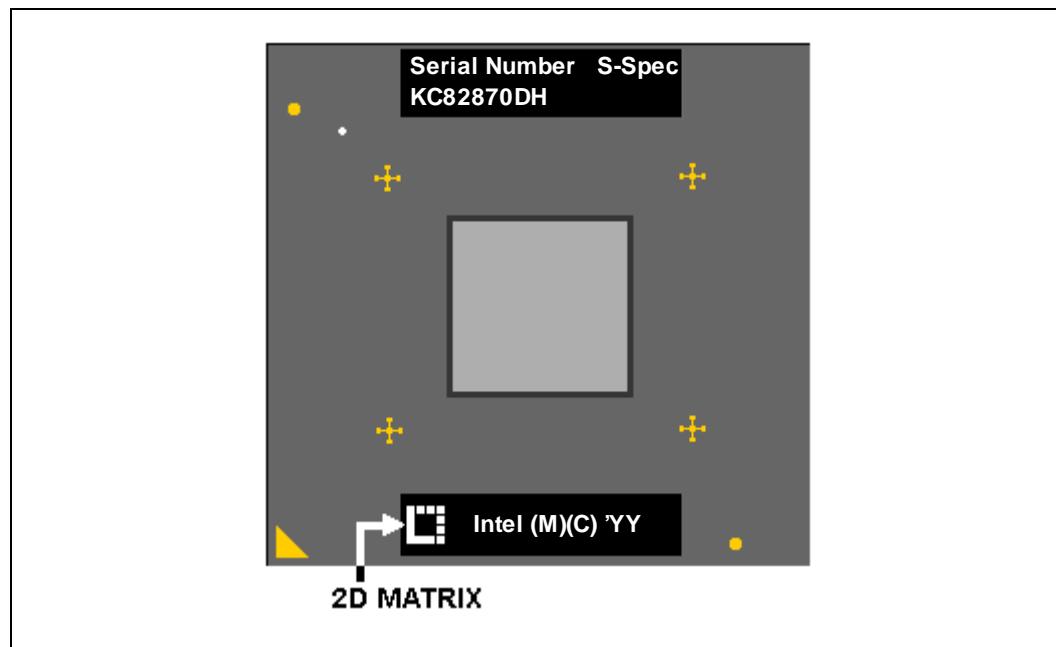
Figure 1-2. DMH Markings

Figure 1-2 shows an example of the DMH component markings which include the following information:

- INTEL Brand/ INTEL Product ID
- Legal Mark
- Serial Number
- S-Spec Number
